Vogue Tower Condominium

Reserve Fund Study

930 6 Avenue SW, Calgary, AB

May 1, 2019

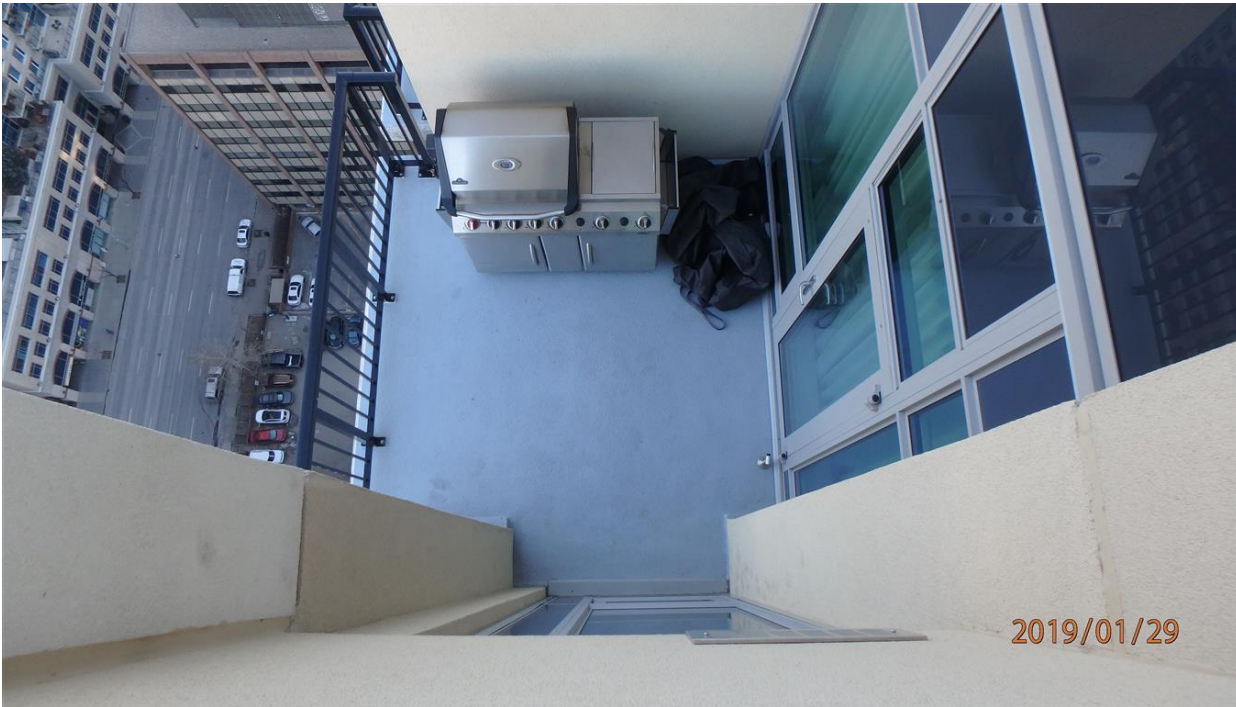
Condition and Recommendations: Metal railings observed to be in good condition. No major repairs are expected (Photo 1).

Photo 1 Typical balcony and aluminum railings

Annual audits should be conducted of railings and rail connections to ensure all safety issues are noted and corrected in a timely manner. A replacement cost has been allocated at the end of service life, however the service life may be extended. This should be reviewed in the next reserve fund study cycle.

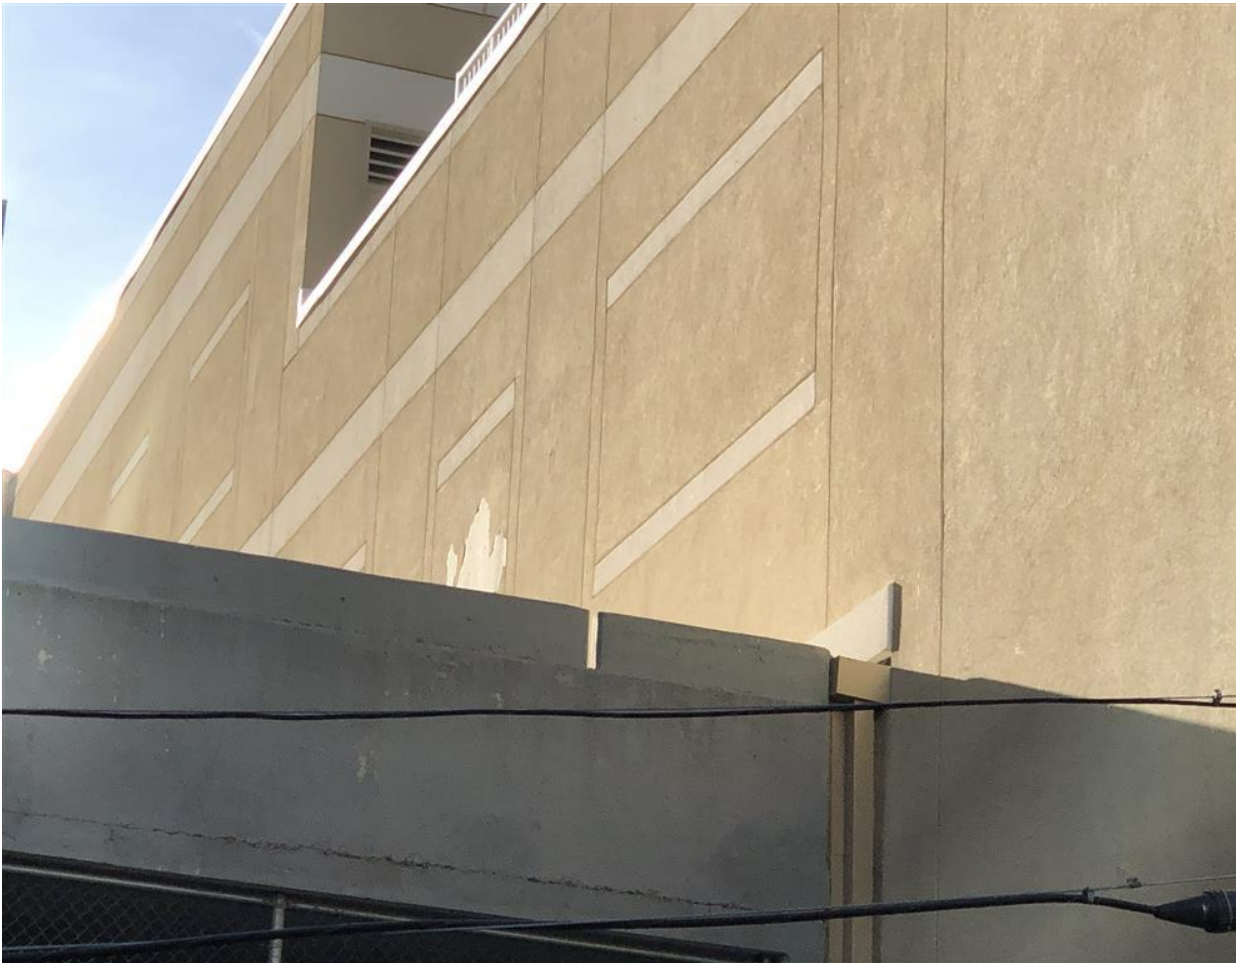
Condition and Recommendations: In general, the EIFS was observed to be in good condition. One area on the East elevation was observed to be de-bonding, this should be repaired immediately by the original contractor (Photo 3). Some water staining was observed on the stucco finish (Photo 4). No major repairs or replacements are expected in the next 5 years.

Photo 3 EIFS delaminating on East wall

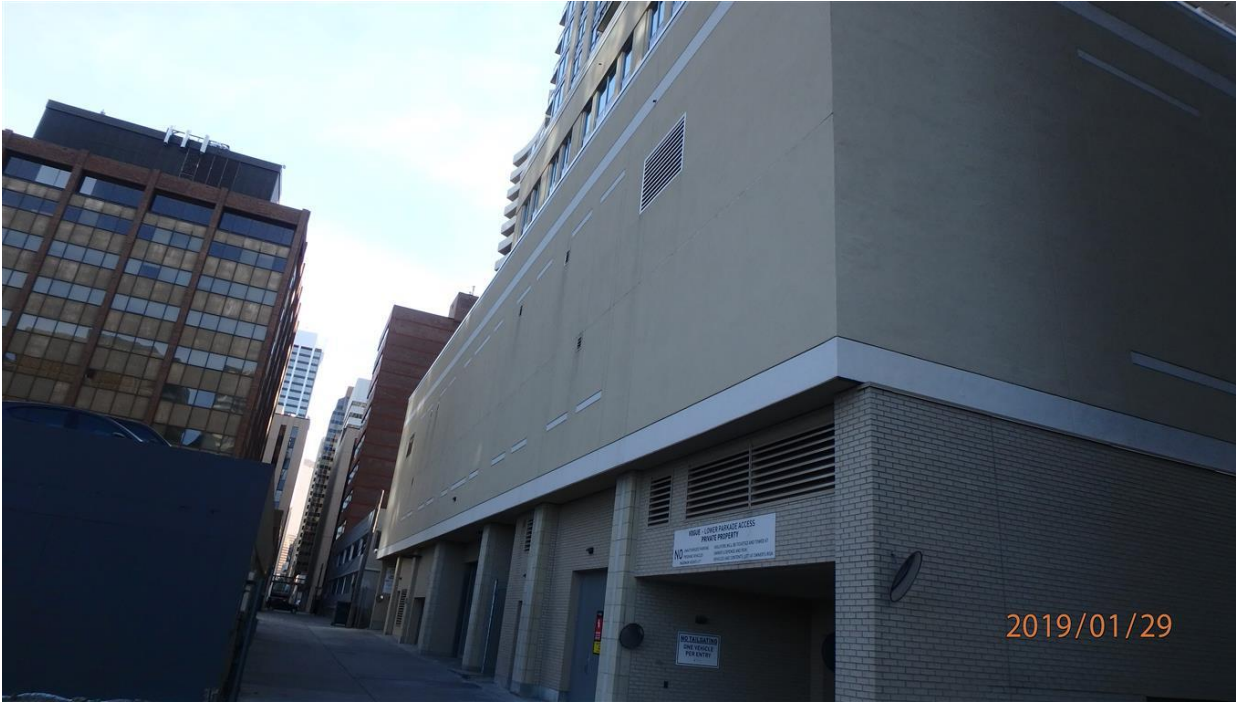
Photo 4 EIFS installed on building. Some water staining can be observed.

General Information: Due to the porous nature of EIFS finishes, staining may eventually become more frequent as the complex ages. Although not a structural concern, this may eventually present an aesthetic problem. If the staining becomes a concern and budgets allow for the removal of this staining, there are two possible approaches. For both methods, we would recommend that a test wall be tried first, and that an established, reputable contractor who fully understands what is expected from their service be retained.

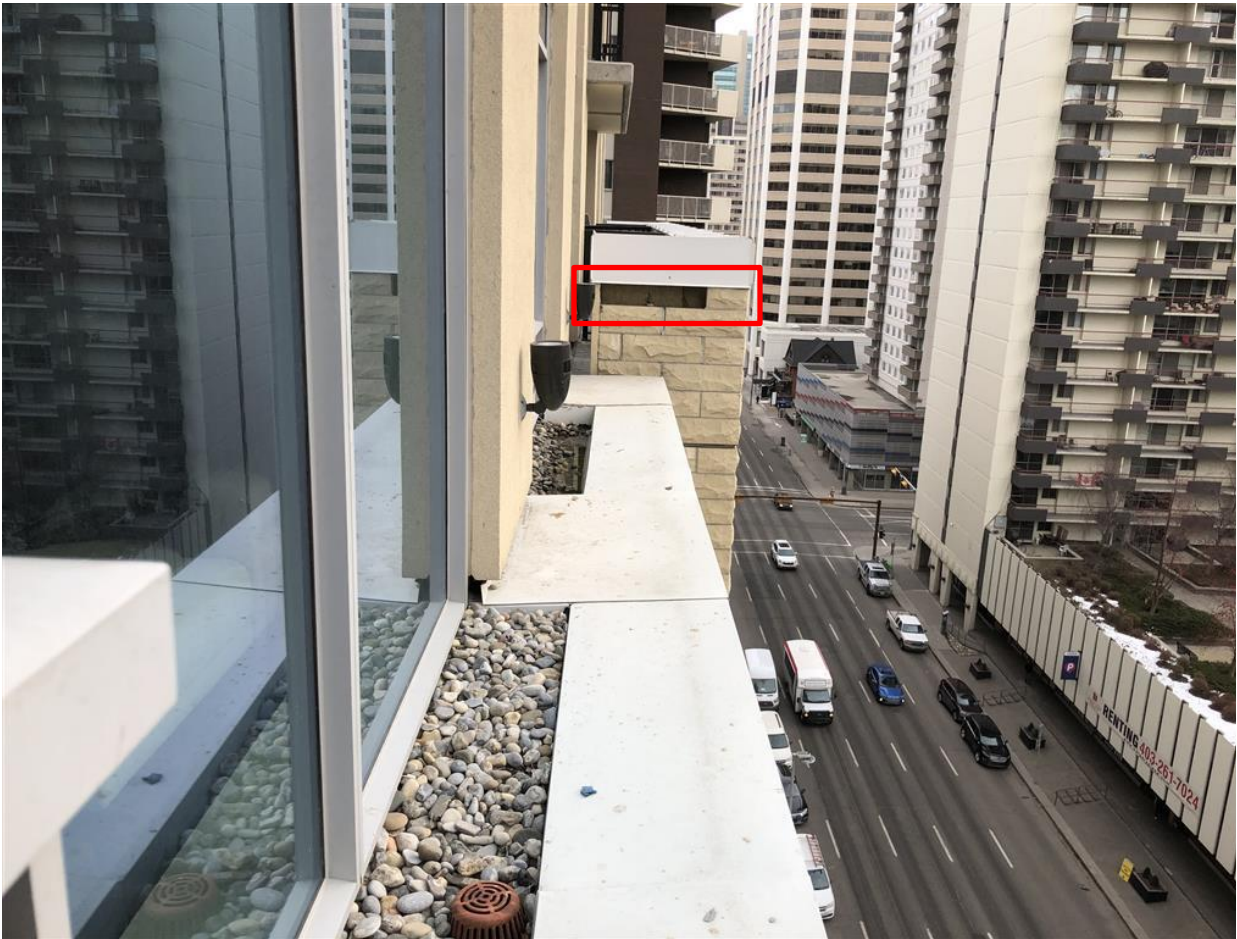
Condition and Recommendations: The stone and brick masonry was observed to be in good condition. Stone was observed to be missing on the South elevation at the 10th floor, this should be repaired immediately by the original contractor (Photo 6). Water staining was observed on the face of the stone (Photo 7). No major repairs or replacements are expected over the next 5 years. Funds have been allocated on a 10-year cycle for brick repair and masonry joint re-pointing.

Photo 6 Stone missing on South elevation

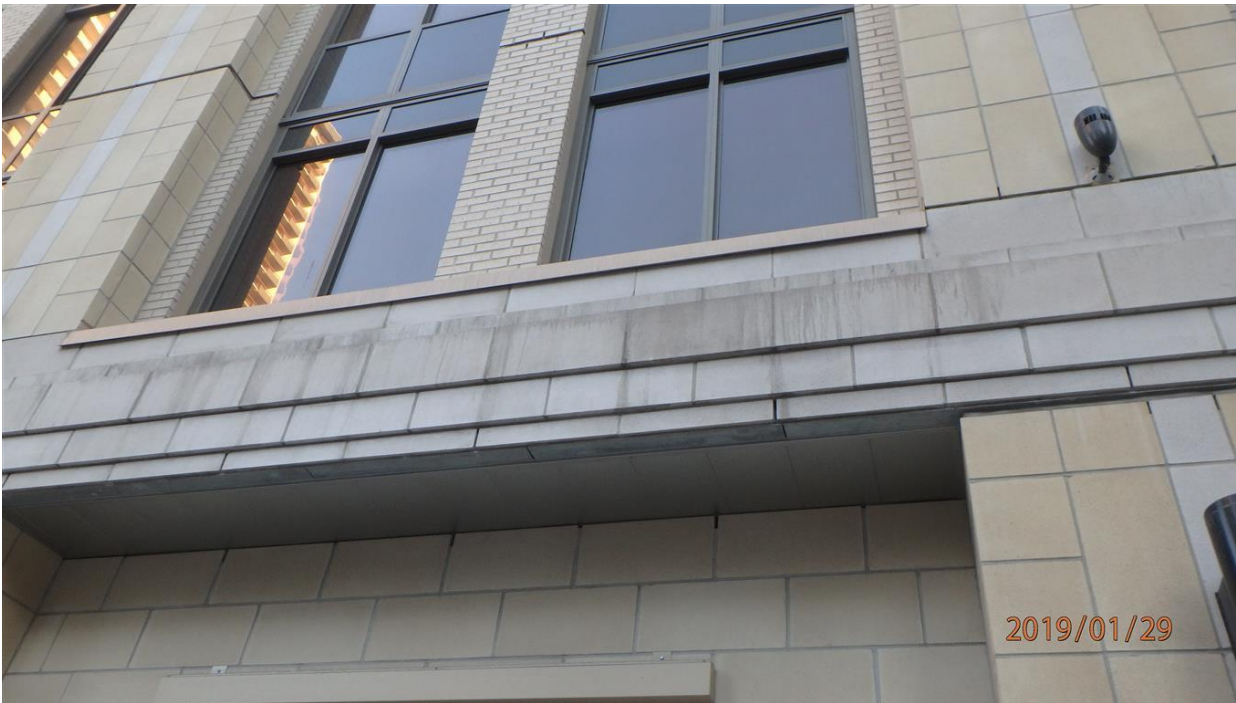
Photo 7 Water staining on stone masonry

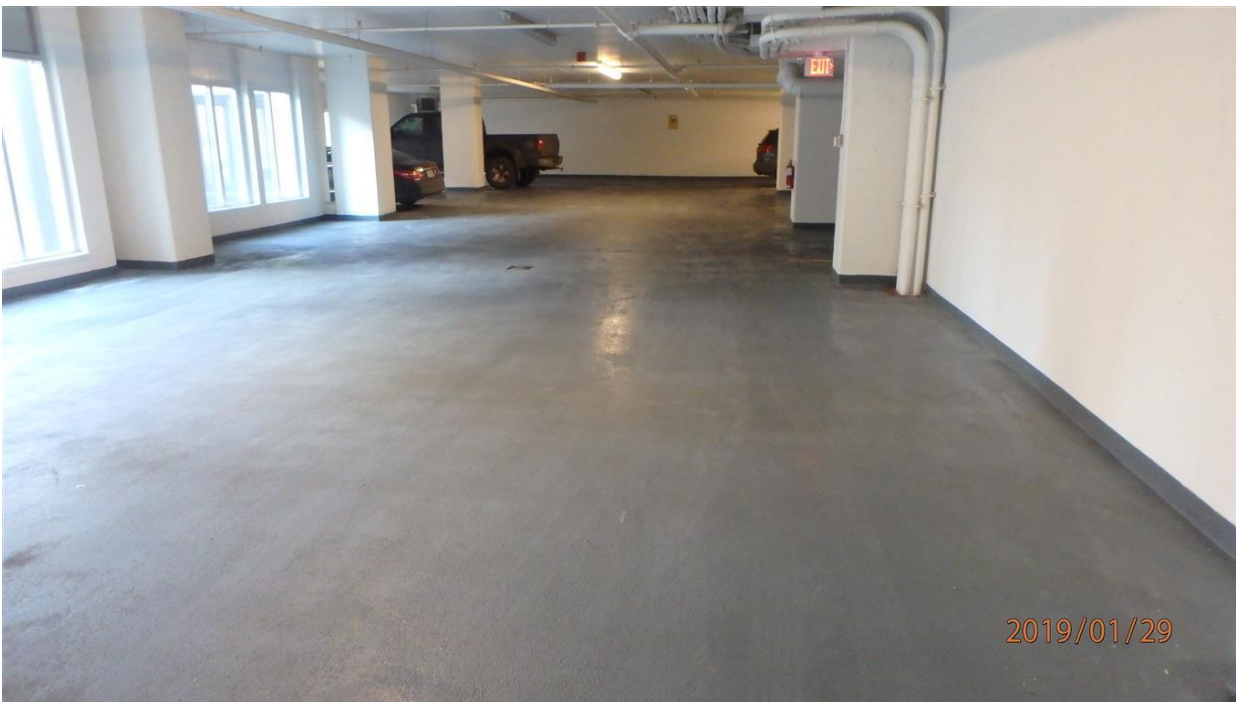
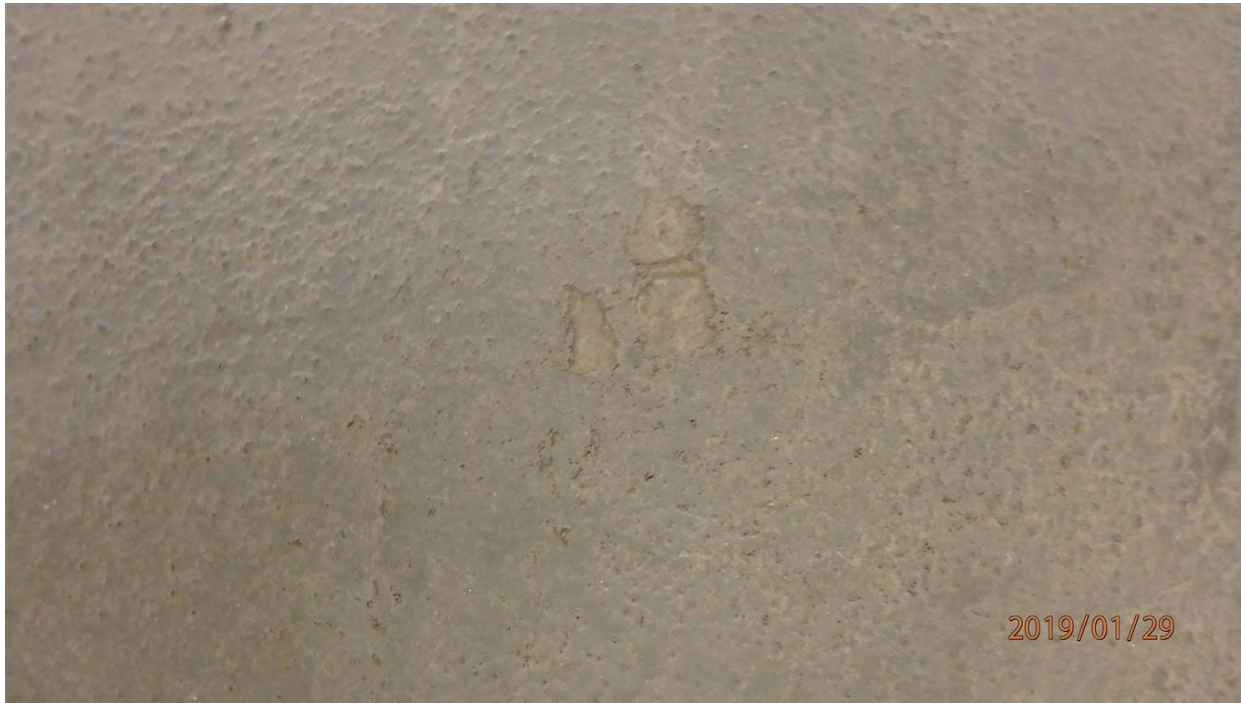
Condition and Recommendations: Membrane was observed to be in good condition with only minor areas of deterioration due to wear noted (Photo 8 & 9). It is recommended that the membrane be reviewed annually for wear and patches applied as needed. Funds have been allocated for the membrane repair every 5 years.

Photo 8 Overview of parkade membrane

Photo 9 Damage to parkade membrane

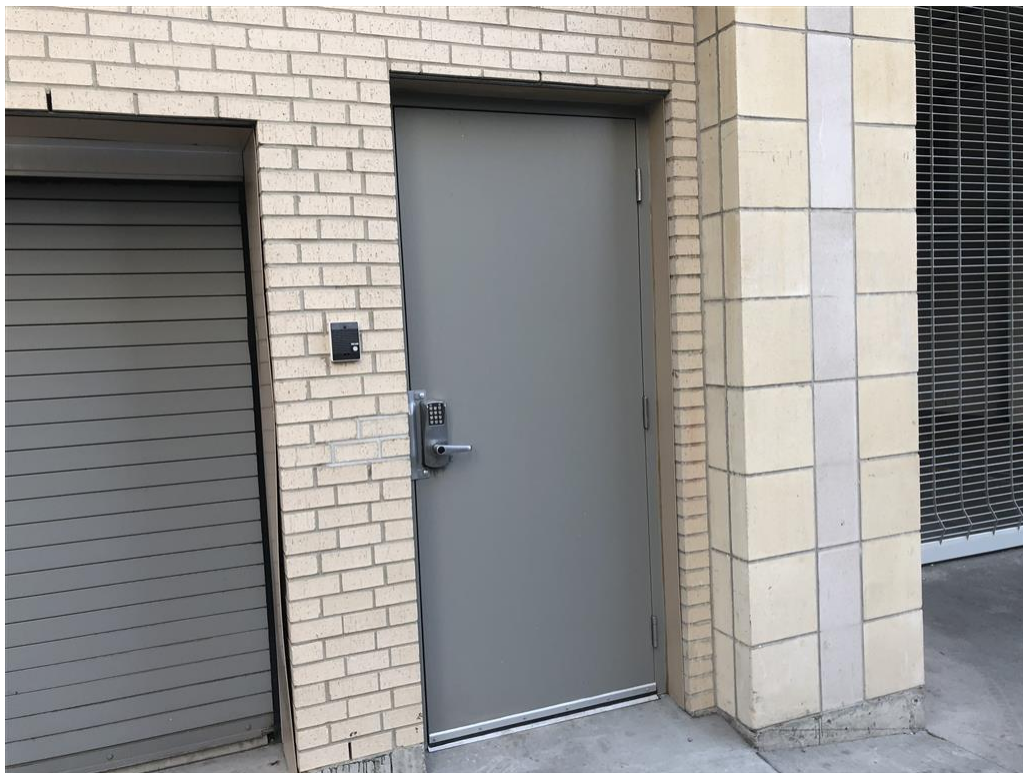
Condition and Recommendations: The metal doors were observed to be in good condition (Photo 12). No major repairs or replacements are expected in the next five years. The replacement value allocated is for the exterior doors only.

Photo 12 Insulated metal man door

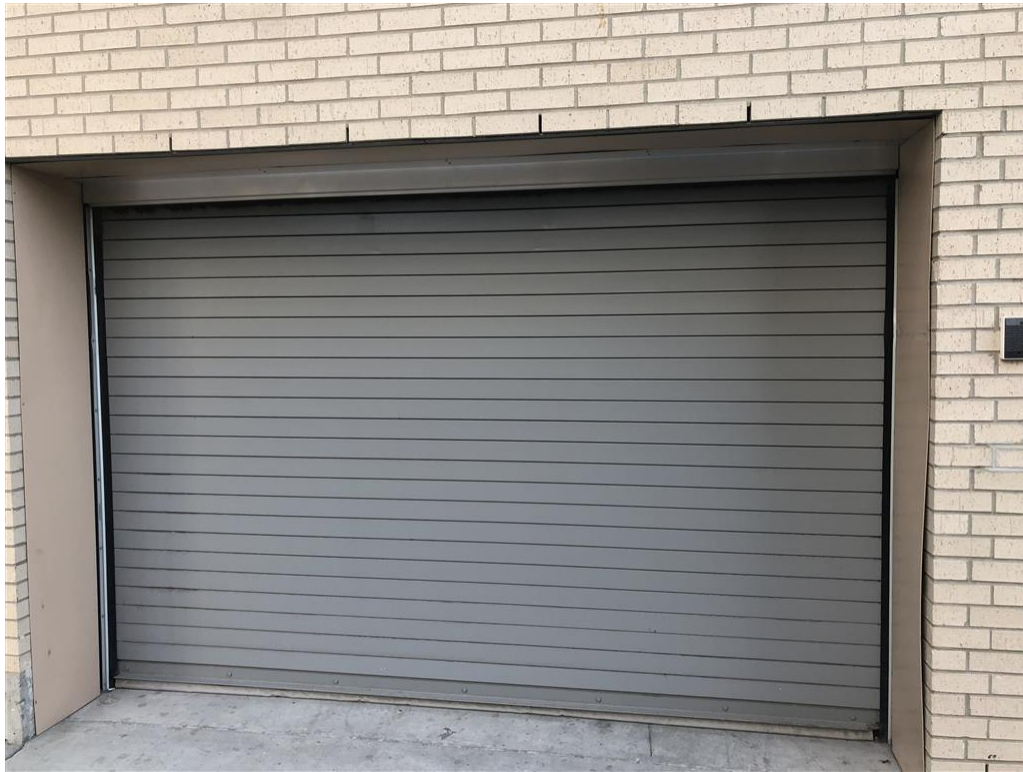
Condition and Recommendations: The overhead doors are in good condition (Photo 13). Door hinges/connections should be lubricated as required. No major repairs or replacements are expected in the next five years. Funds have been allocated at every 5 year increment.

Photo 13 Overhead door

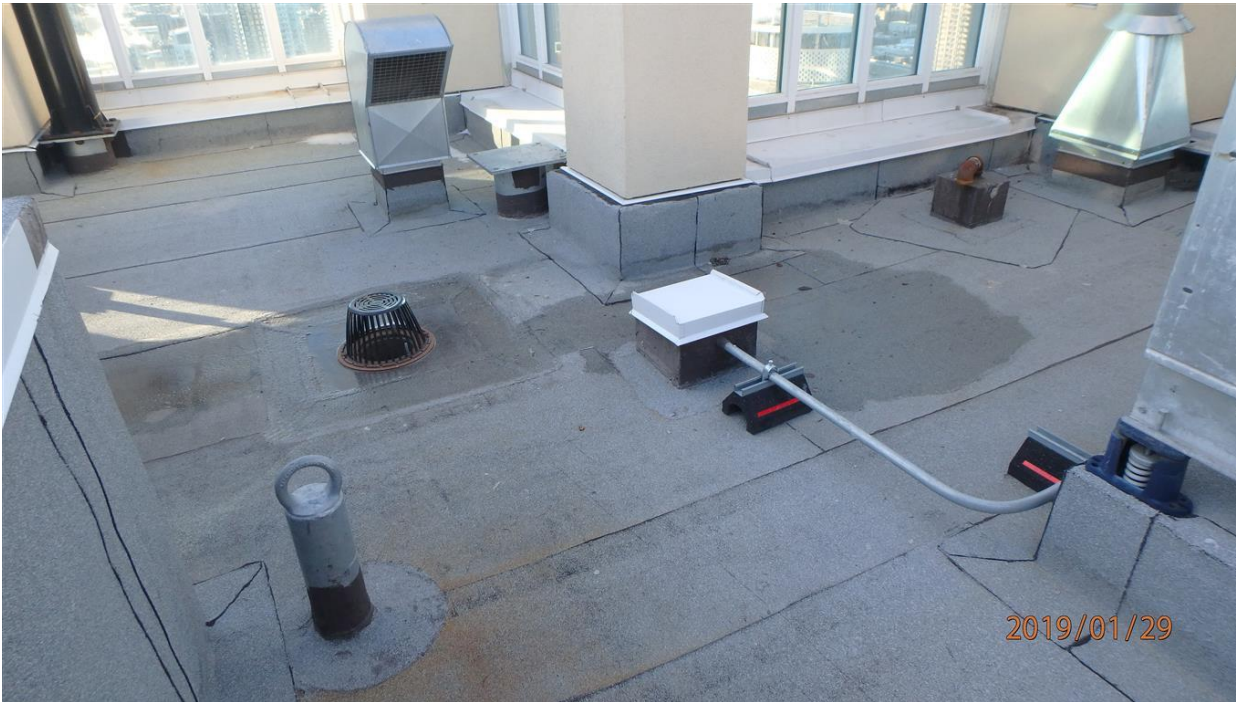
Condition and Recommendations: The roof was observed to be in good condition (Photo 14). It is recommended that the membrane is reviewed annually for damages and debris is removed from the roof and around drains. Funds have been allocated for replacement at the end of the service life spread.

Photo14 Overview of conventional 2-ply SBS roof

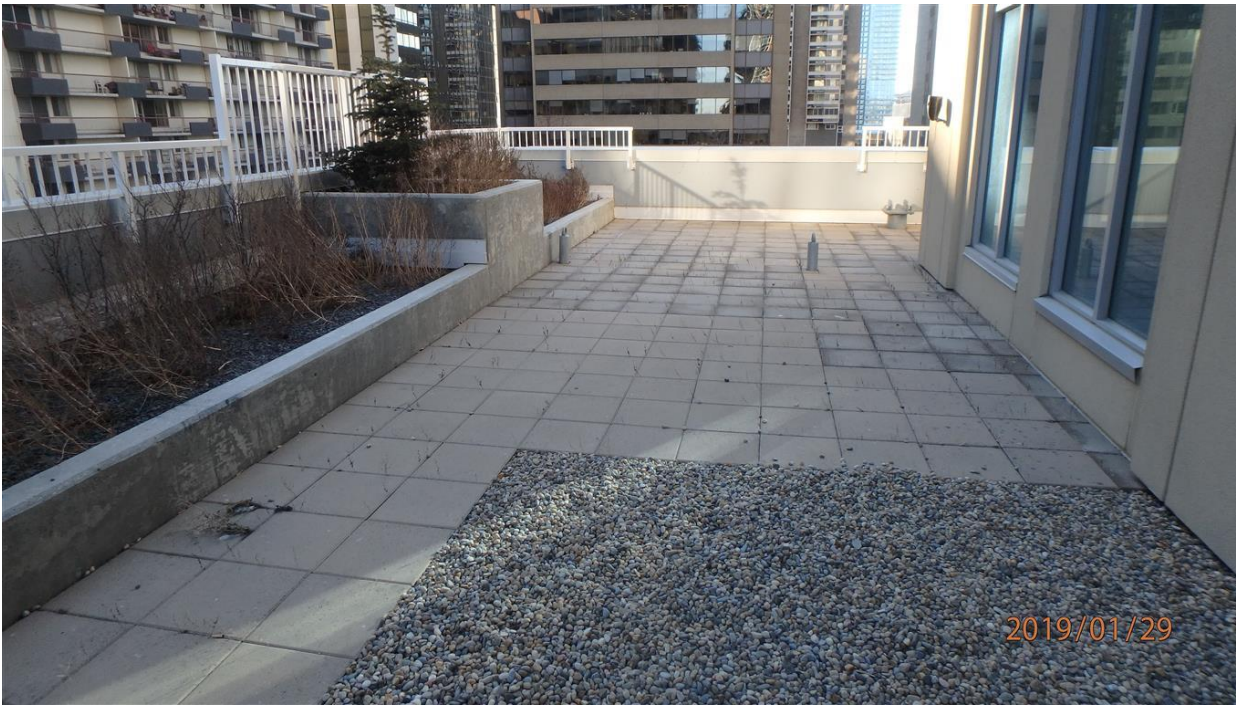
Condition and Recommendations: The roof was observed to be in good condition (Photo 15). It is recommended that the roof be reviewed annually for damages and debris is removed from the roof and around drains. Funds have been allocated for replacement at the end of the service life spread over 2 years.

Photo 15 Overview of inverted SBS roof

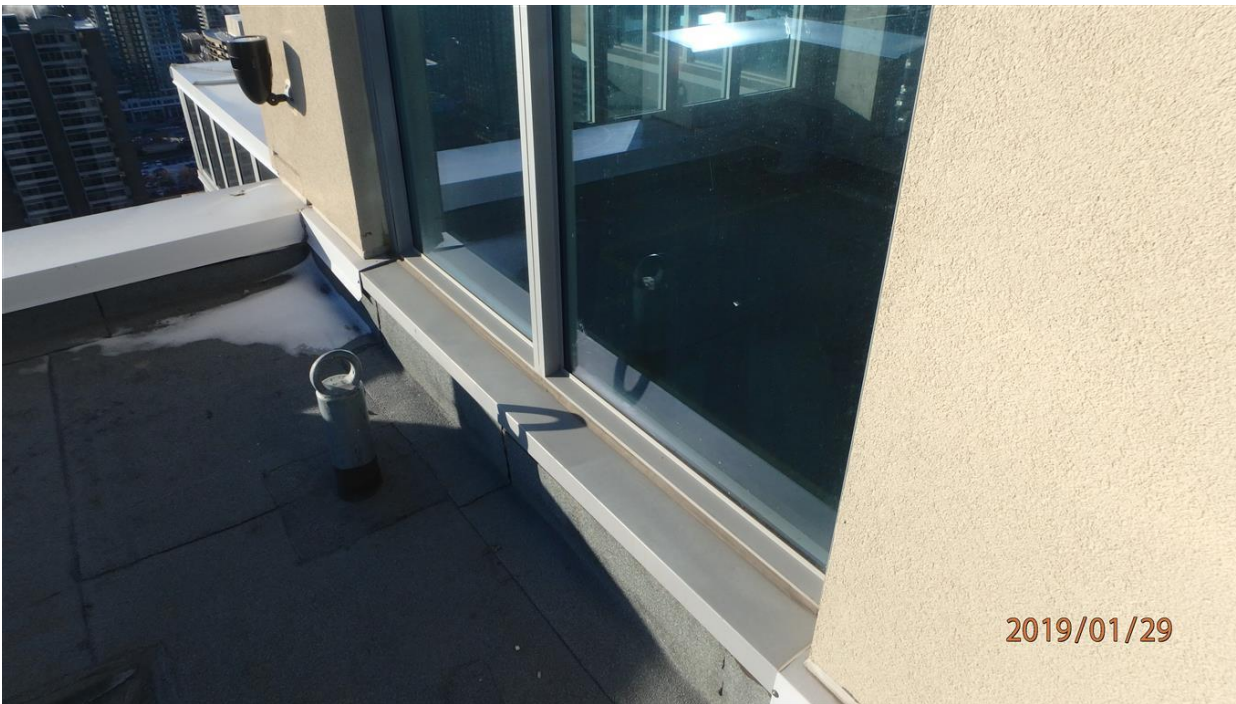
Condition and Recommendations: Metal flashings on the building were observed to be in good condition (Photo 16). No major repairs or replacements are expected in the next 5 years.

Photo 16 Typical metal flashing

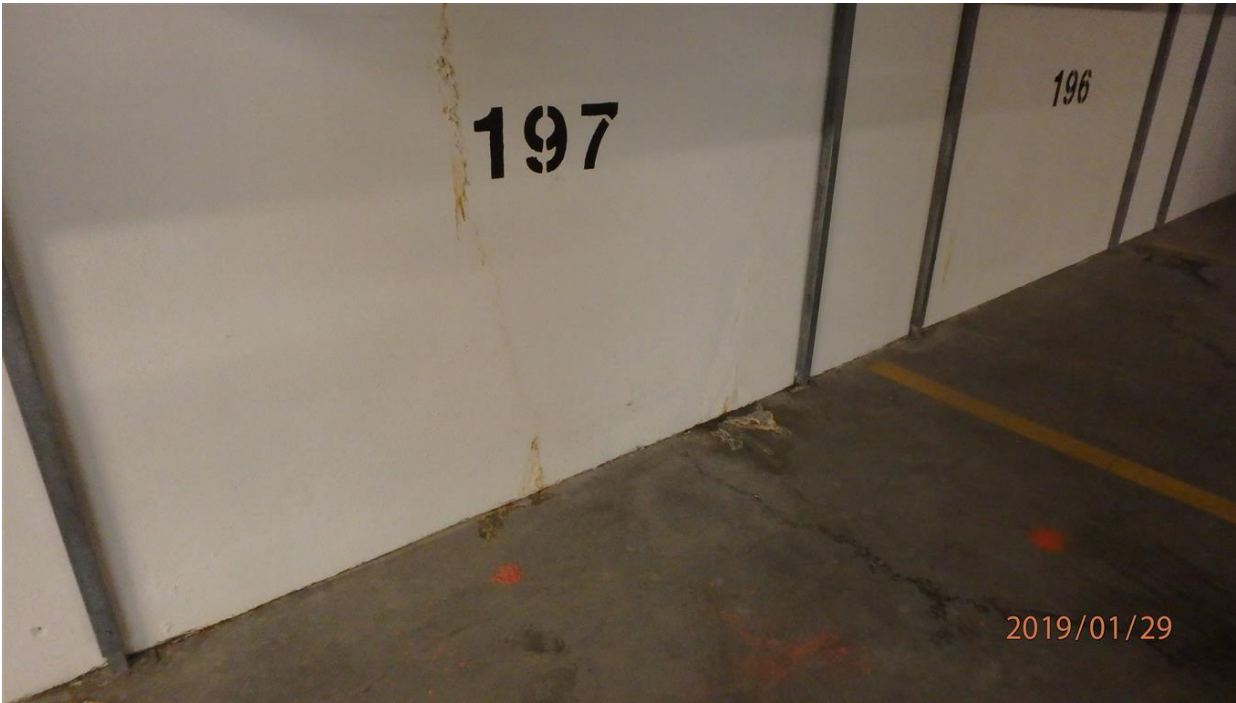
Condition and Recommendations: The condition of the blind-side bentonite waterproofing cannot be observed however leakage was observed from the interior of the building on the concrete foundation walls and slabs (Photo 17). This should be reviewed and repaired by the foundation waterproofing contractor if it is still under warranty. Leakage was observed on levels P4 and P5.

Photo 17 Leakage observed on concrete walls from interior of building

Funds have been allocated for potential leak repair at various locations on the concrete walls every 10 years starting in the next year due to existing leaks being present should this not be covered under existing warranties.

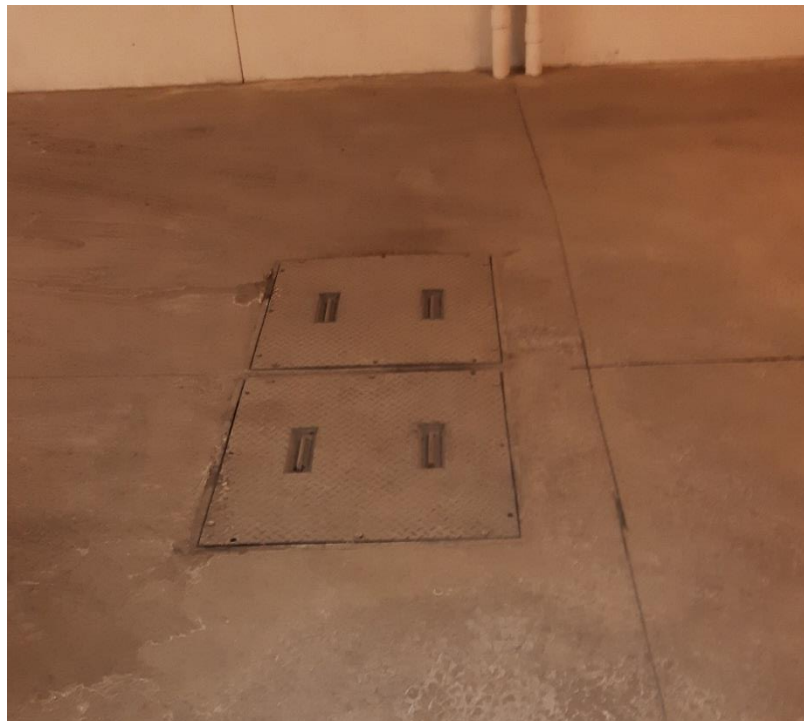
Photo 8 Sanitary sump floods during Fire Pump testing

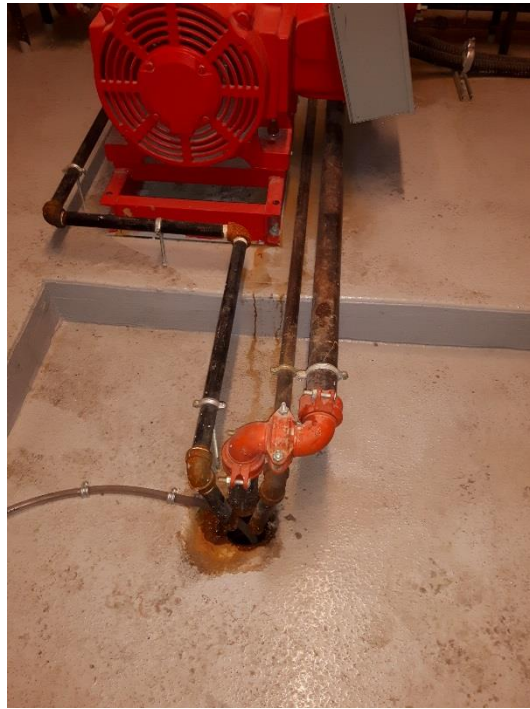
Photo 9 Fire Pump discharge down to sanitary sump in parkade
